DOE/NV--1052

Post-Closure Inspection and  
Monitoring Report for  
Corrective Action Unit 417:  
Central Nevada Test Area - Surface,  
Hot Creek Valley, Nevada

For Calendar Year 2004

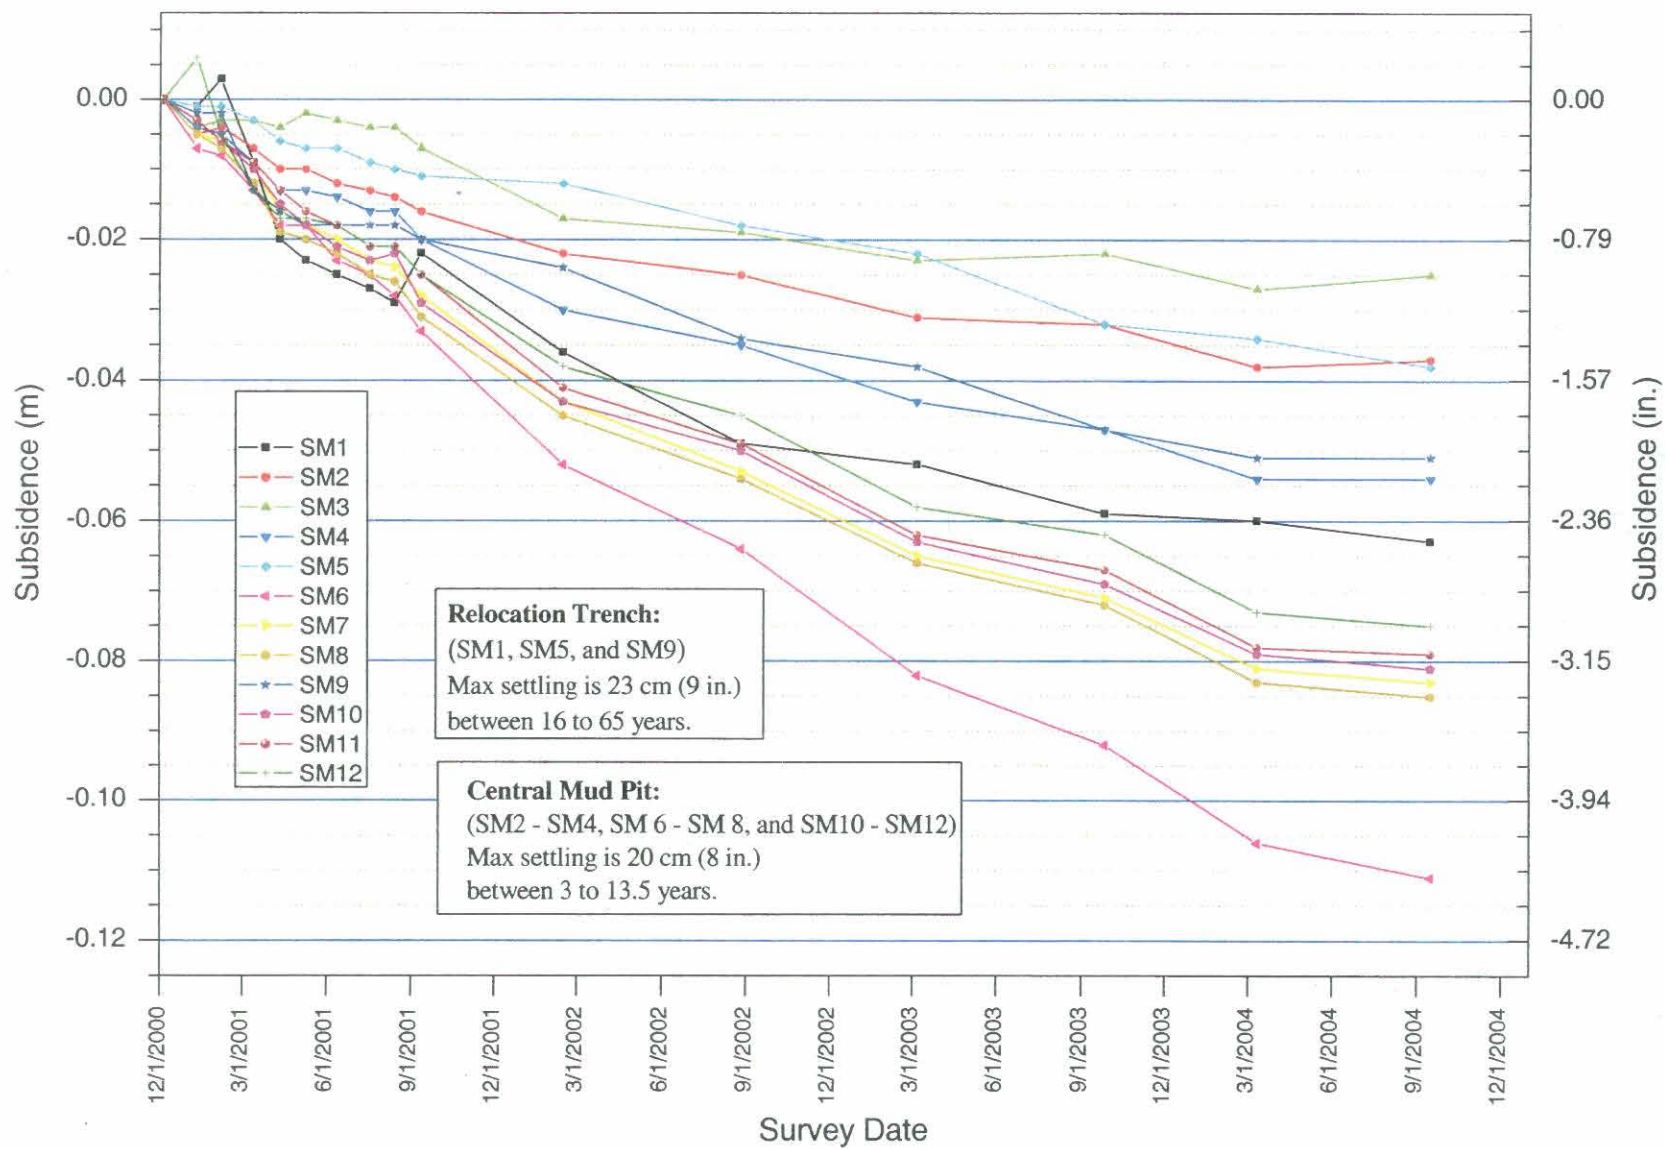
**FIGURE 4**  
**UC-1 COVER SETTLING**

Subsidence surveys were conducted at UC-1 and UC-4 in March and September of 2004. The results of the subsidence surveys indicate that the covers are performing as expected, and no unusual subsidence was observed.

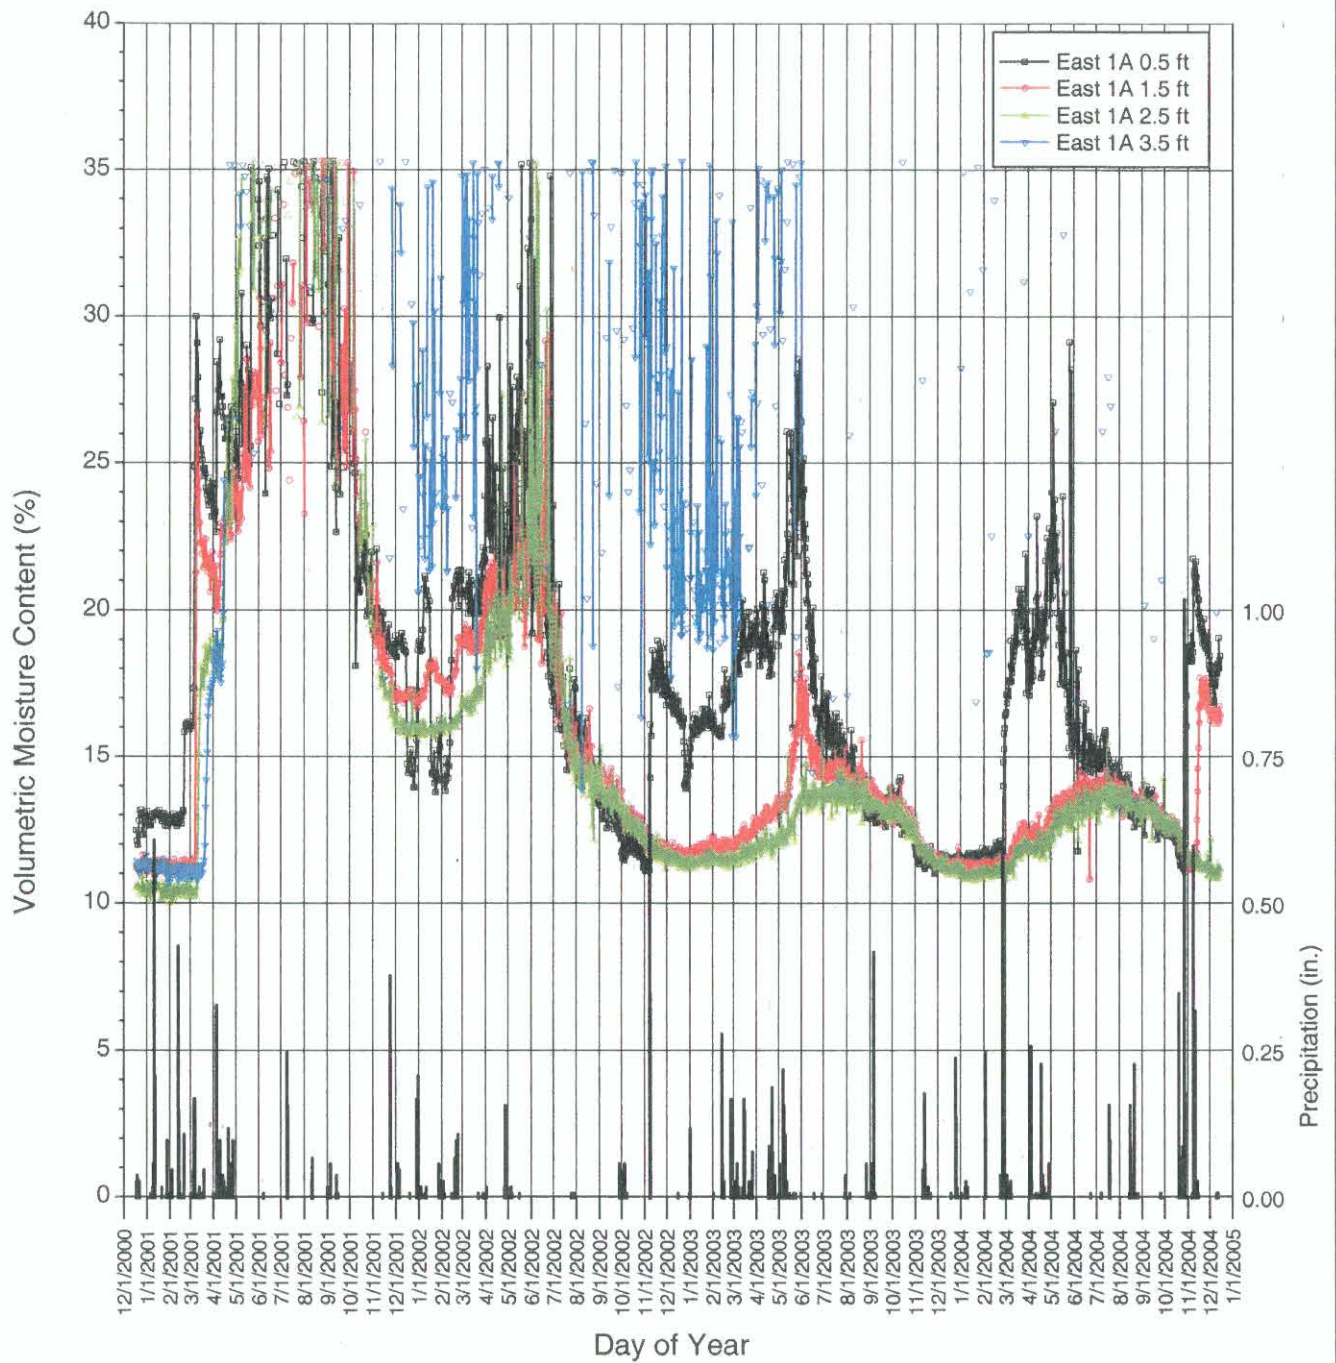
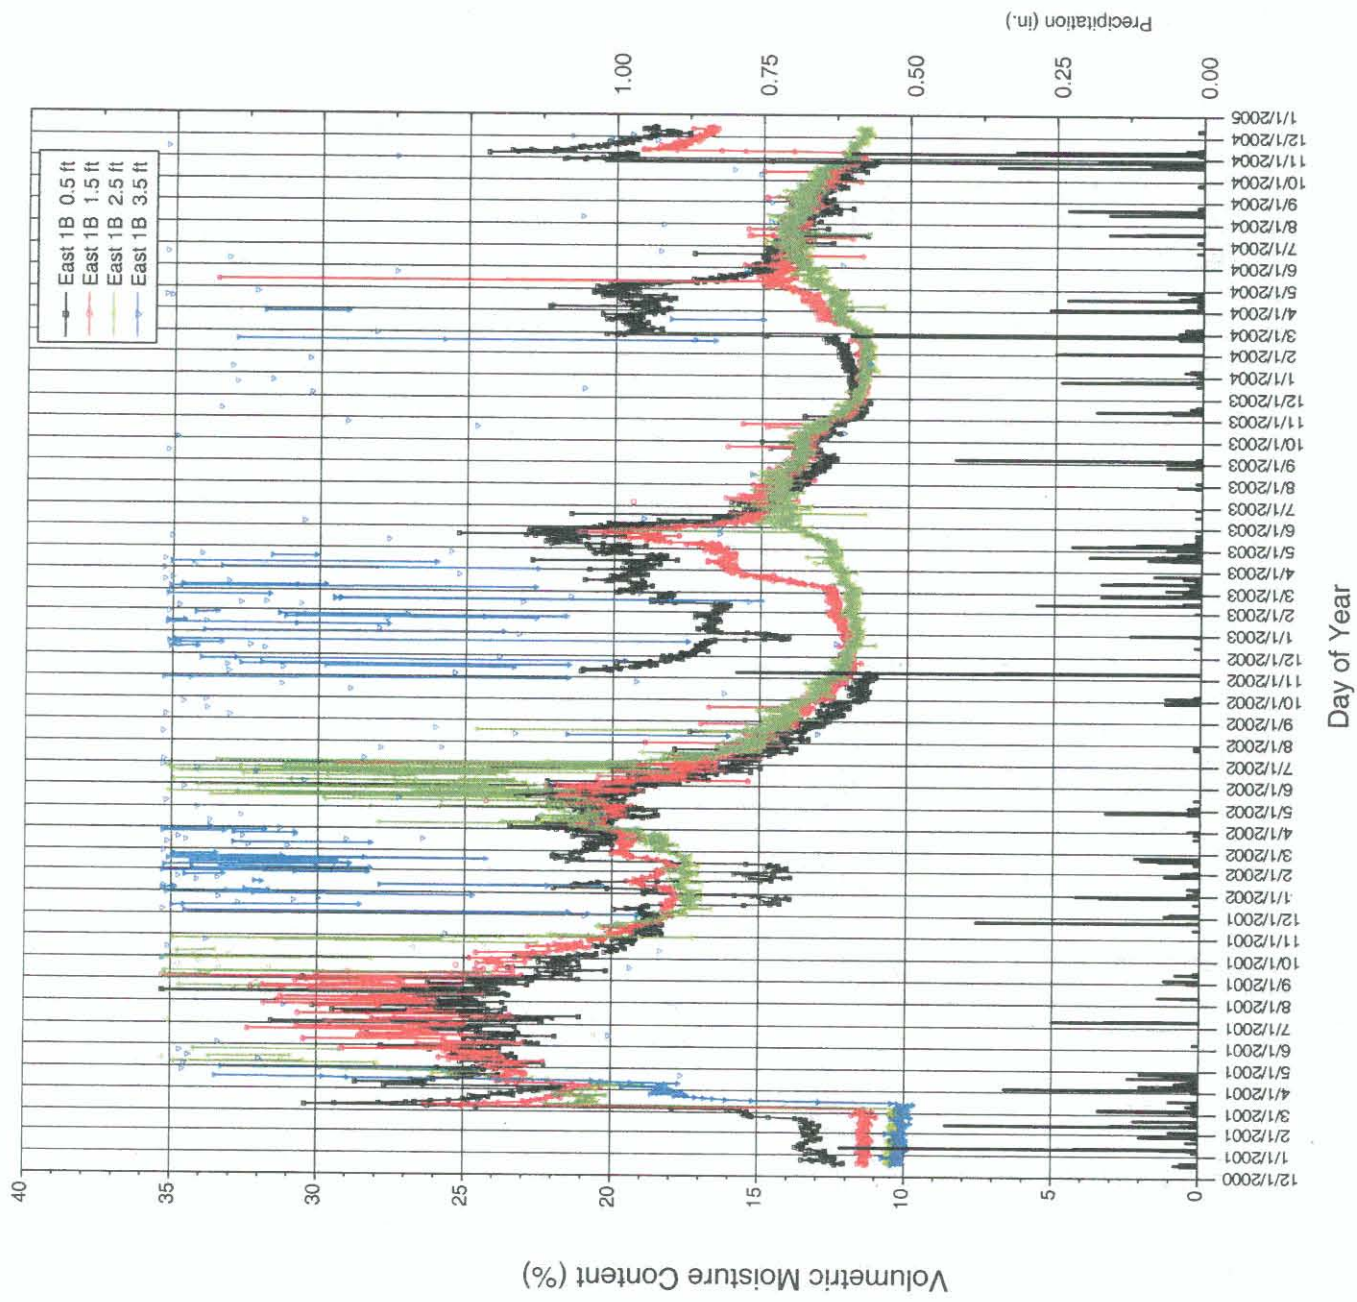
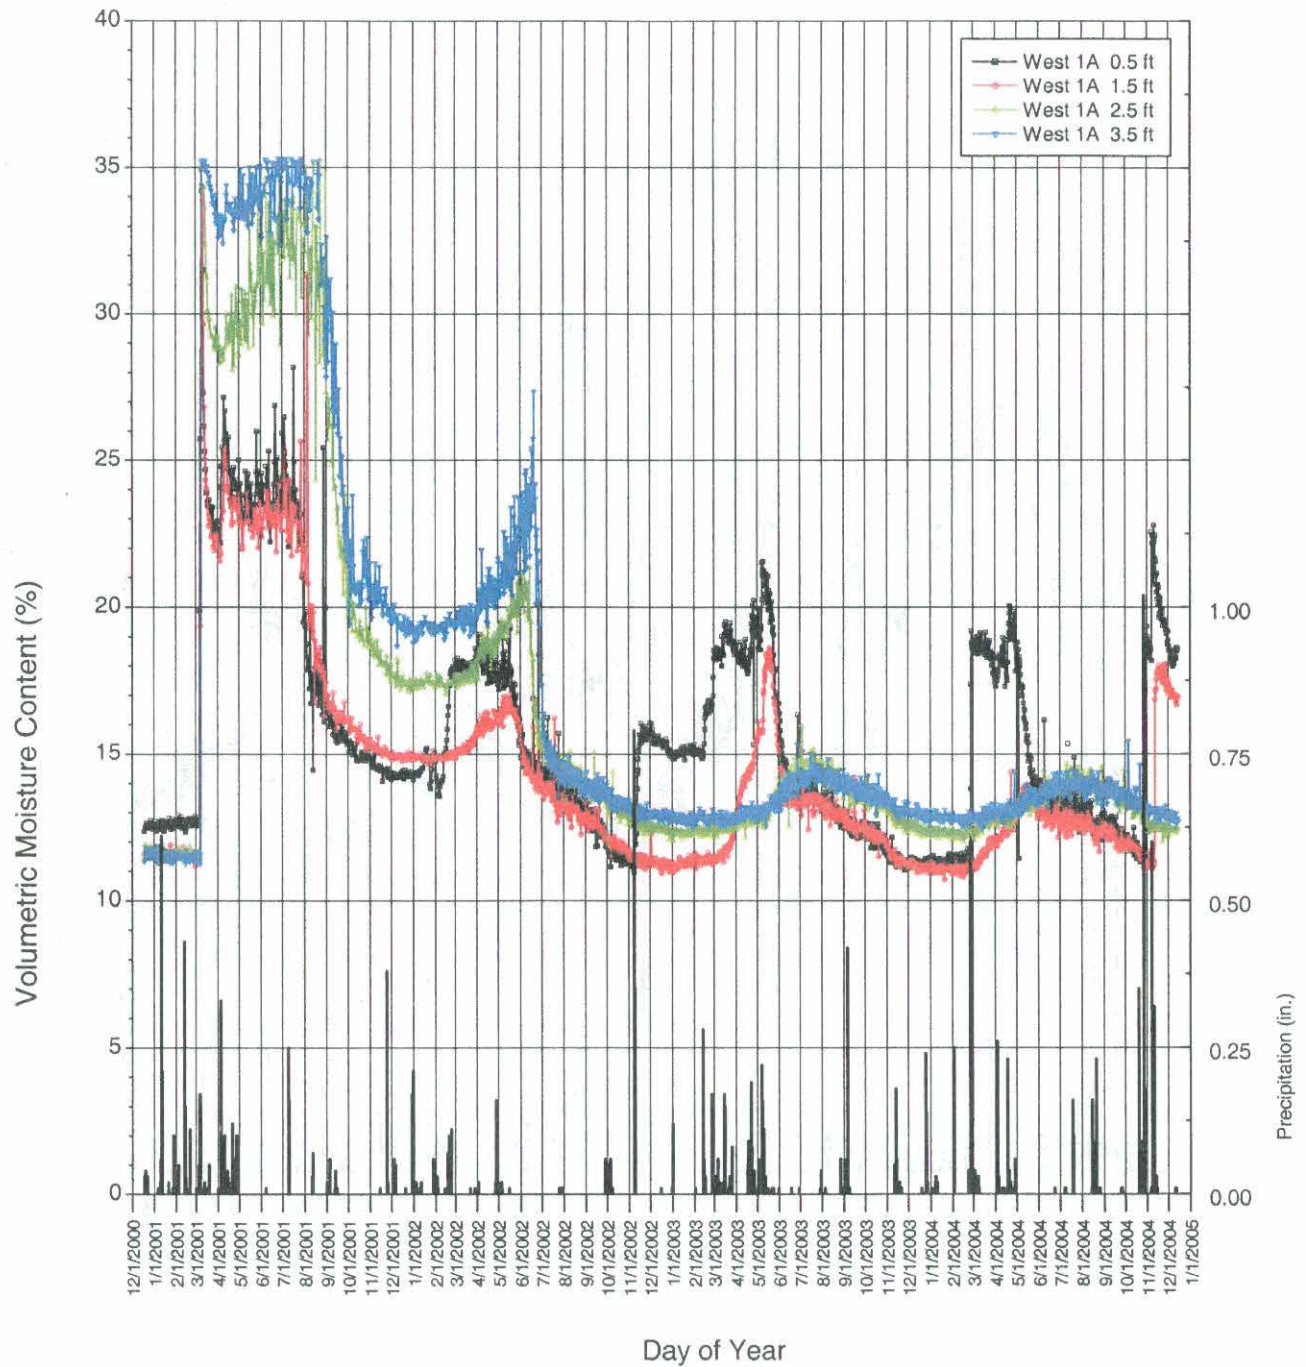
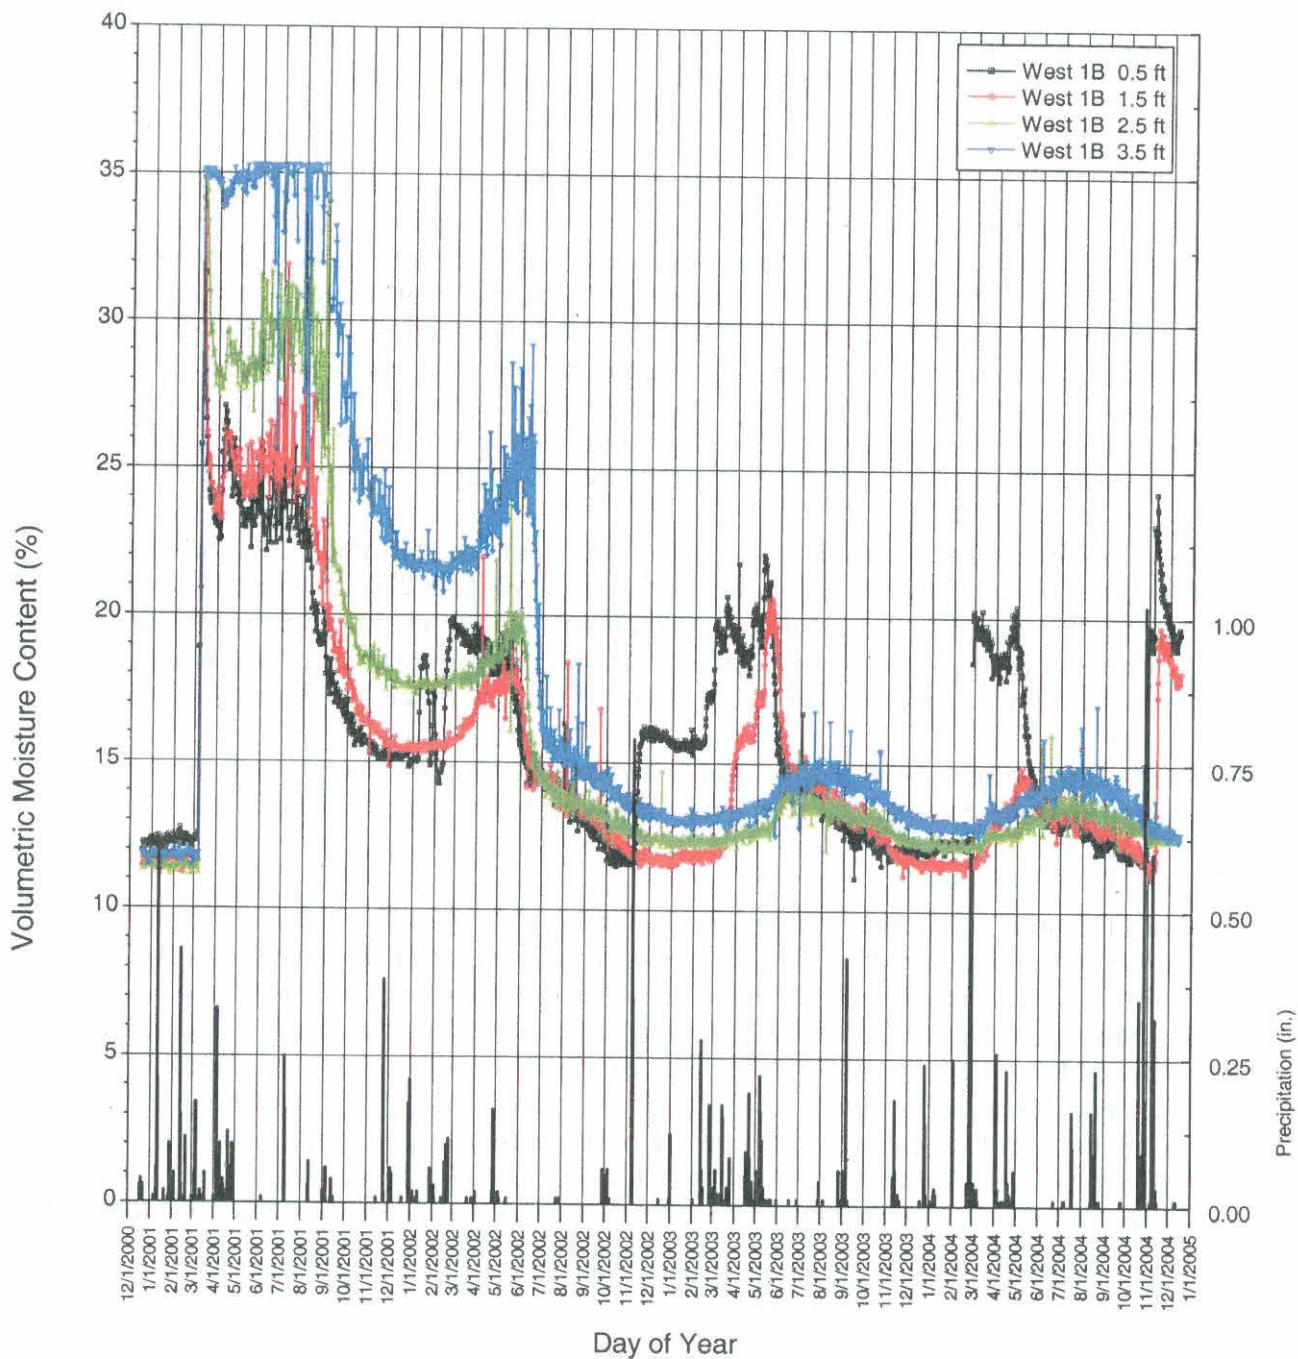
Soil moisture content data show that the UC-1 CMP cover is performing as designed with saturated conditions at the cover-mud interface and evapotranspiration effectively removing water from the cover.

The soil moisture graphs, Figures 7 through 10, show several responses: the initial conditions, wetting events, infiltration, and the return to steady-state conditions under both barren and vegetated conditions. The initial conditions at the beginning of the data collection reflect the disturbed soil's intrinsic moisture conditions. The installation of the TDR probes is described in detail in the CR (NNSA/NV, 2001). The trenching and compaction of each of the soil lifts disturbed the soil profile and resulted in a vertical moisture content profile that was not necessarily monotonic with depth as would be expected with a natural profile. Consequently, some depths appeared wetter than others and will remain so until the system fully equilibrates. As noted earlier, vegetation is not established directly over the TDR nests, only surrounding them. Therefore, some excess infiltration and lower than normal evapotranspiration can be expected until the vegetation over the TDR nests become established.

Wetting events can be seen as a rapid rise in the VMC in the shallow depths and lag in time as this pulse moves down through the cover soil to depth. All the profiles indicate a rapid increase in moisture content at the end of February 2001. This is coincident with temperatures rising above the freezing point, which allowed the snow melt to infiltrate as a sudden pulse. The rate of

infiltration on the barren cover was remarkable, especially on the west nests. Both the east and west nests remained very wet through July 2001, when the moisture contents began to fall, due to germination of the plant cover and evapotranspiration over the hot summer months. At the 1.1 m (3.5 ft) depth for both nests, the soil was saturated. This was a primary design feature of the cover and is due to the weight of the cover and settling, which forces the water out of the mud, making it available for root uptake and evapotranspiration.

It is recommended to continue quarterly site inspections and the collection of soil moisture data for the UC-1 CMP cover.

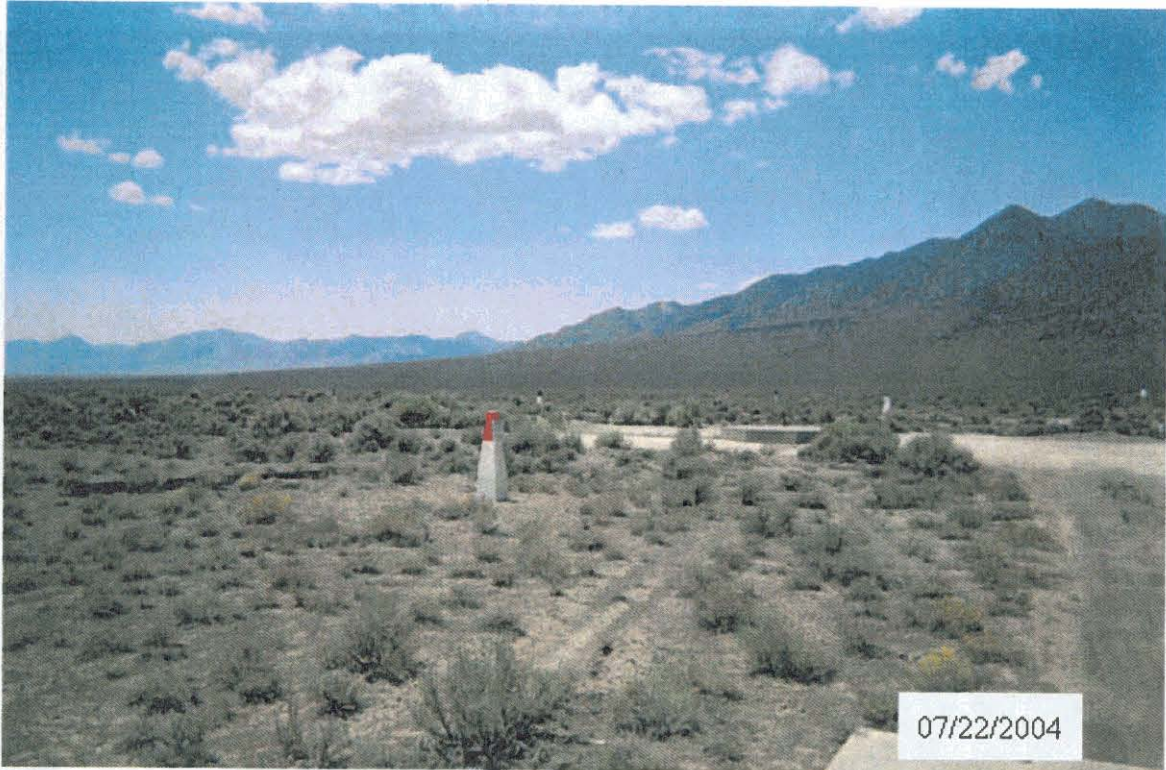
Photograph 17: UC-3 Monument installation

The inspections at UC-3 indicated that the sites are in excellent condition. It was recommended during the March inspection that new monuments be installed on the UC-3 Southern Outlier (CAS 58-25-01), and this activity was performed in July. Signs were mounted on the monuments during the September inspection. No other issues or concerns were identified.

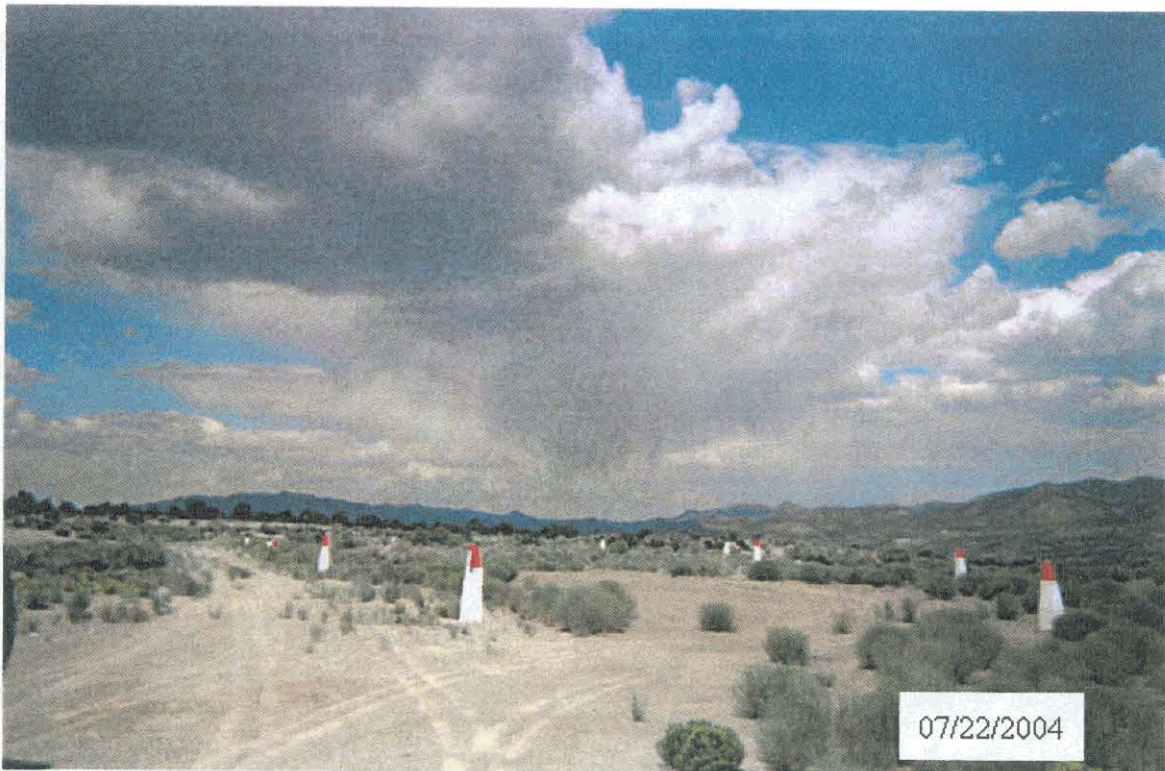
Photograph 18: UC-4 Mud Pits A and B monument installation

Inspections performed at UC-4 indicated that the sites are in good condition. It was recommended during the March inspection to install six new monuments to better demarcate the boundary of Mud Pits A and B. The monuments were installed in July, and signs were mounted on the monuments during the September inspection. No issues were identified with the monuments, fence, or gate.

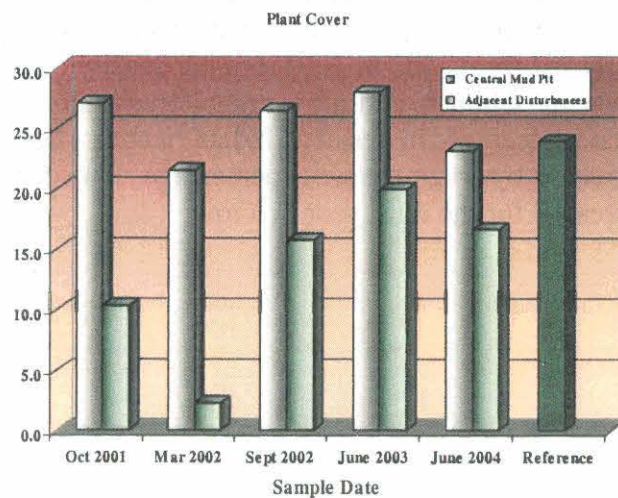
Figure 1. Total plant cover from 2001 to 2004 on the CMP, adjacent disturbances, and reference area

The vegetation on the CMP and adjacent disturbed areas is becoming well established. The amount of total plant cover appears to have stabilized over the last couple years (Figure 1). Plant cover on the both the CMP and the adjacent disturbed areas was less this year than was measured on the reference area, but the difference is not significant. The reduction in cover is probably a result of several factors with the most obvious being the continued effects of below normal precipitation. More precipitation was received this growing season than in the previous two seasons; however, the

timing of the precipitation did not favor perennial plant growth. Another contributing factor is the decrease in plant density. In the revegetation process, a decline in plant density is anticipated as is an associated increase in plant cover. Basically, there are fewer plants competing for the same resources. However, the lack of adequate moisture again this year did not favor plant growth, although there were fewer plants competing for the little moisture that was received. The decrease in plant cover from 2003 to 2004 was 17 percent for the CMP and adjacent disturbed areas. Cover on the adjacent disturbed areas continues to be less than on the CMP. In 2003 and 2004, cover has increased to about 72 percent of the soil cap on the CMP. This is an improvement compared to plant cover in the spring of 2002, when it was critically low and represented about 10 percent of the cover inside the fence.

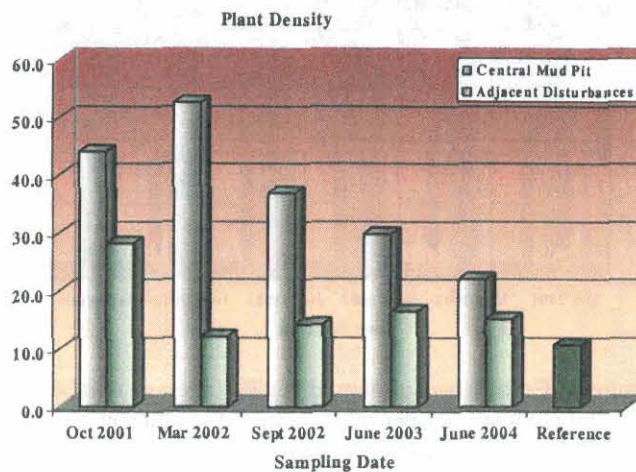
Figure 2. Comparison of plant density on the CMP, adjacent disturbed areas, and reference area

The decreases in plant density suggest that a percentage of the plants are dying annually as resources become more limited. Plant density has declined every year since the site was revegetated in the fall of 2000. However, plant density on these revegetated areas is still almost double the density of plants found in the native plant communities (Figure 2). There has been a 20 to 30 percent reduction in the density of seeded plants on the CMP every year since March 2002. On the adjacent disturbed areas that were seeded but not fenced, plant density is lower, and since March 2002, it has decreased by 5 percent. Changes in plant density have ranged from a low of 12.1 plants/m<sup>2</sup> in March 2002 to a high of 16.6 plants/m<sup>2</sup> in 2003. Although plant density was only 15.0 plants/m<sup>2</sup> in 2004, 30 percent lower than on the CMP, there are still more plants per unit area than in the native plant community. The rate of decline in plant density has been greater on the CMP, but after four years plant density is still double in the surrounding native plant communities.

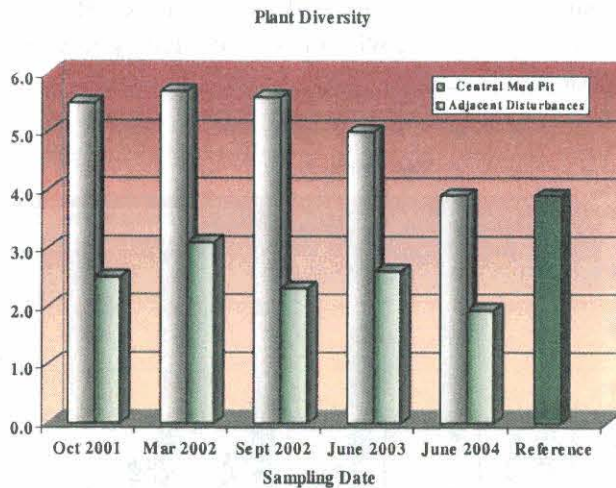
Figure 3. Comparison of plant diversity (average number of different plant species per m<sup>2</sup>) on the CMP, adjacent disturbed areas, and reference area.

Plant diversity, which is another measure of the vigor of the vegetation, continues to be higher on the CMP compared to the native vegetation (Figure 3). All of the shrubs either seeded or planted onto the site are established on the CMP. Outside the fence, plant diversity is not as good. As seeds were germinating and young seedlings tried to root and become established, they were quickly exposed to herbivores, and many young seedlings of big sagebrush, rabbitbrushes, and Indian ricegrass did not survive. Only fourwing saltbush seemed to survive, even though it was also severely browsed. Fourwing saltbush has managed to withstand the pressures of herbivores and drought the last couple years, which has not been the case for the other species that were seeded. As a result, there are about half as many plant species on adjacent disturbances as there are on the CMP. Many plants on the CMP flower and set seed annually. Seed from surrounding native plant communities is also infiltrating these sites. With favorable growing conditions, more species may eventually become established, and plant diversity may improve. In 2004,

there are as many species on the revegetated areas as there are in the native plant community. The composition is different between the two sites. There is a near equal mix of perennial shrub, perennial grass and herbaceous species in the native plant community. On the CMP there are three times as many shrubs as there are grasses and the contribution of herbaceous species is negligible, although the later category has increased the last couple years.

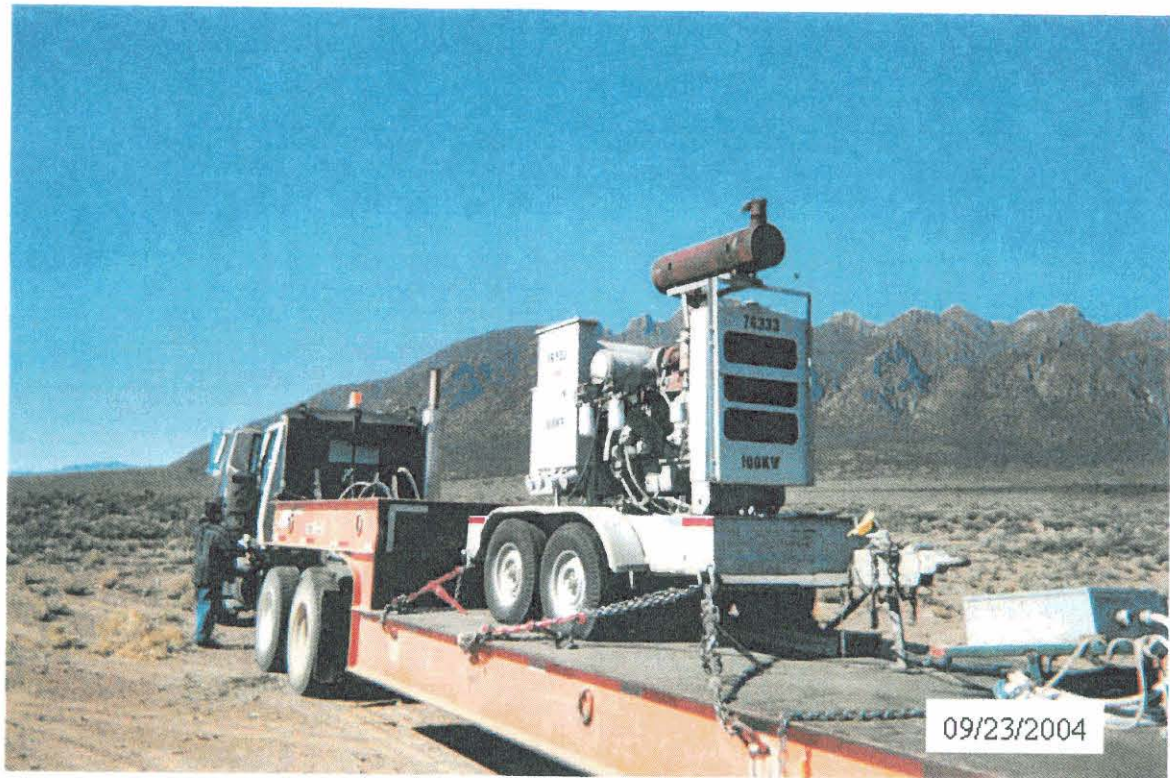
Photograph 1: Generator and Pump Control Panel

- Breaker tripped - short in cable - Shut down generator  
- Recommend pull pump & test at ground & attach new cable
- 12:00 pm - rolled up fire hose, detached pipe junction from wellhead
